# Manhole Inspection Summary

Manhole # S11CC2010MH

Insp Date: **7/28/06 10:21 AM**

**Location** Address: **5805 DALE RD**

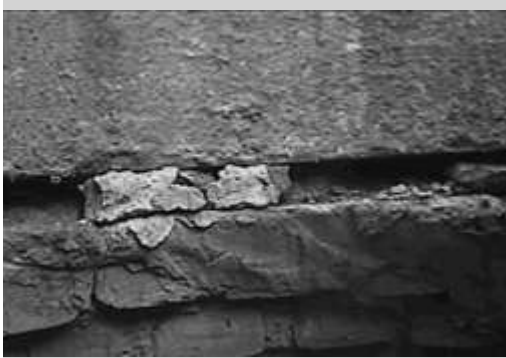
Defect

☒ **Leaks**

Condition: ☐ Sound ☐ Cracked ☐ Root Intrusion ☐ Loose Brick ☒ **Deteriorated**

Infiltration: ☐ None ☒ **Joint** ☐ Cracks ☒ **Mortar** ☐ Roots ☐ Wall

Frame leaks. Adjustment deterioration and infiltration.

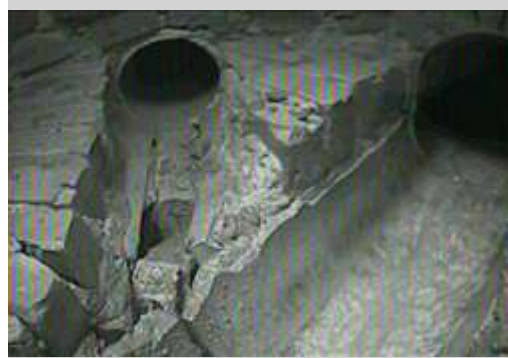
Defect

Condition: ☐ Sound ☐ Cracked ☐ Root Intrusion ☒ **Deteriorated** ☐ Leaks ☐ Debris

Bench and Channel deterioration.

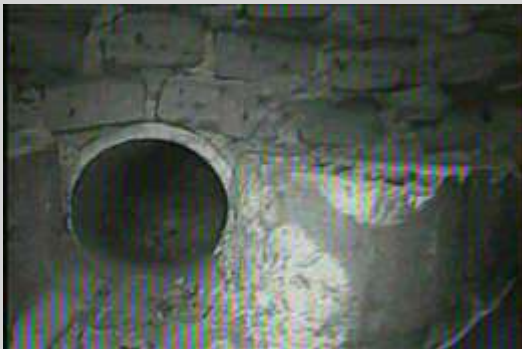
### 6 in. Circular Gravity Sewer Pipe In @ 3 O'Clock

Barrel deterioration and infiltration.

Infiltration: **Evidence**

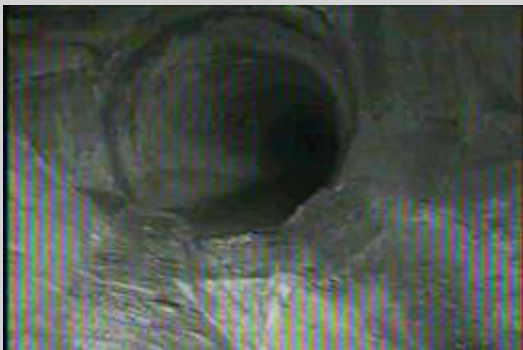
### 8 in. Circular Gravity Sewer

Infiltration: **Evidence**
